Photo 1: Overview of the rear of the Facility. Taken 5/26/15.

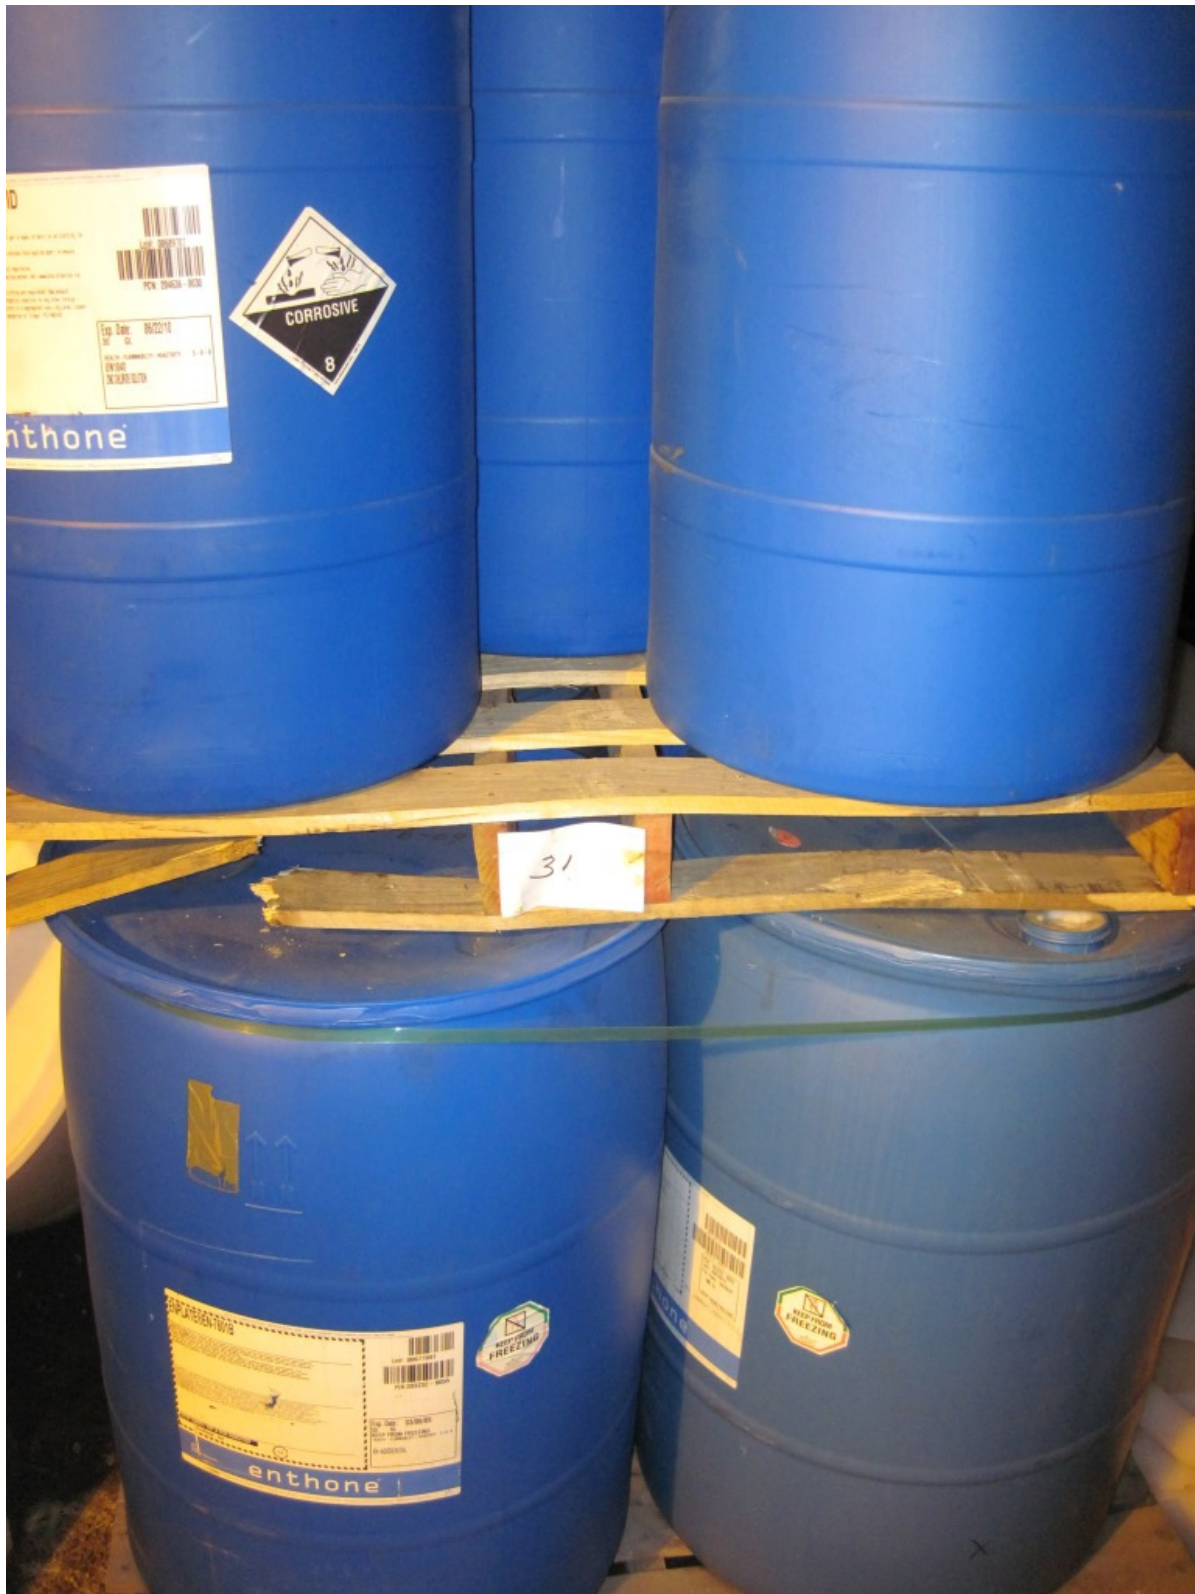
Photo 19: Overview of stacked containers on pallets located close to the former Electropolishing Department. The containers are closed and labeled with product labels.

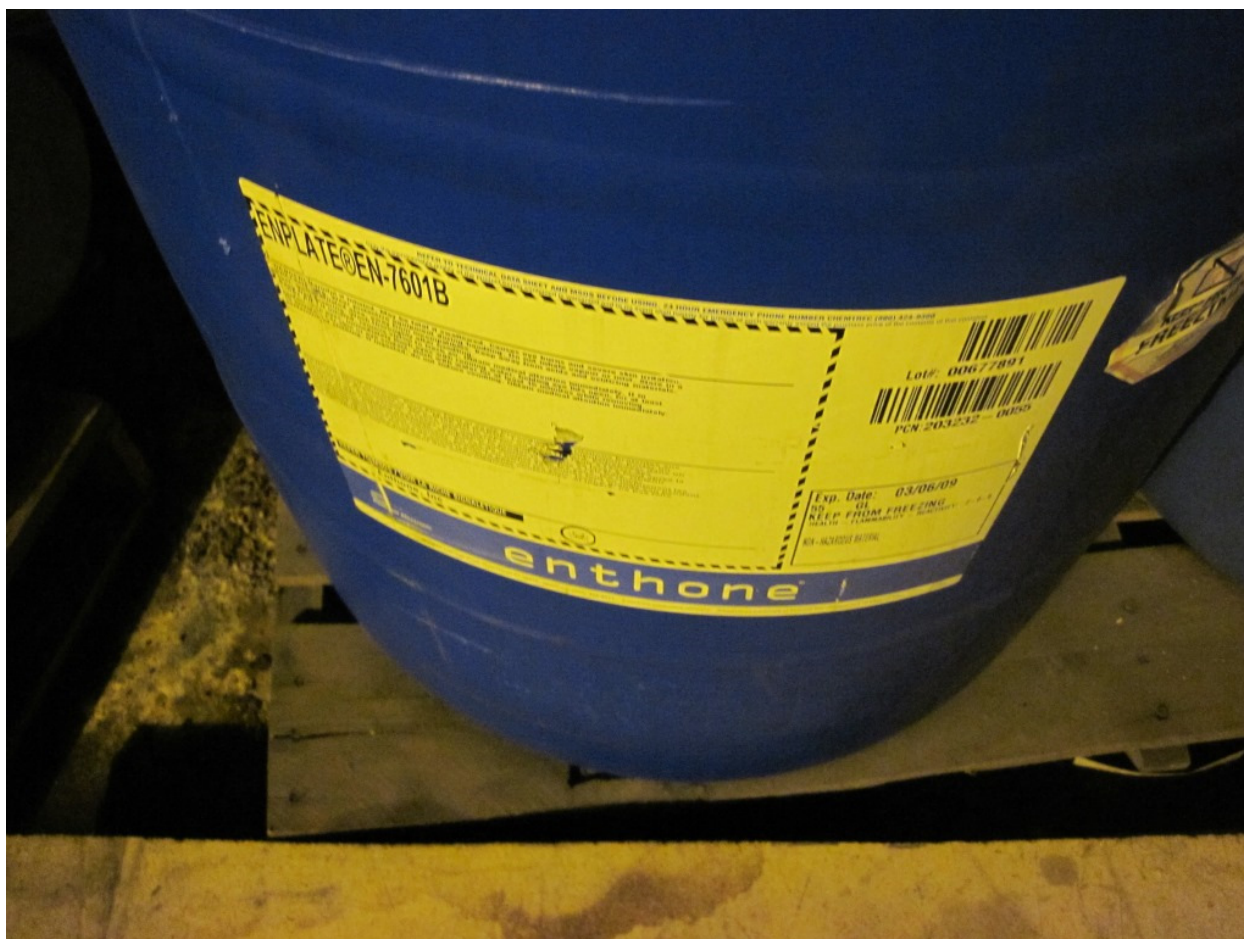
Photo 20: Close-up of the label on one of the containers, as seen in Photo #19 above. The expiration date is 3/6/09.

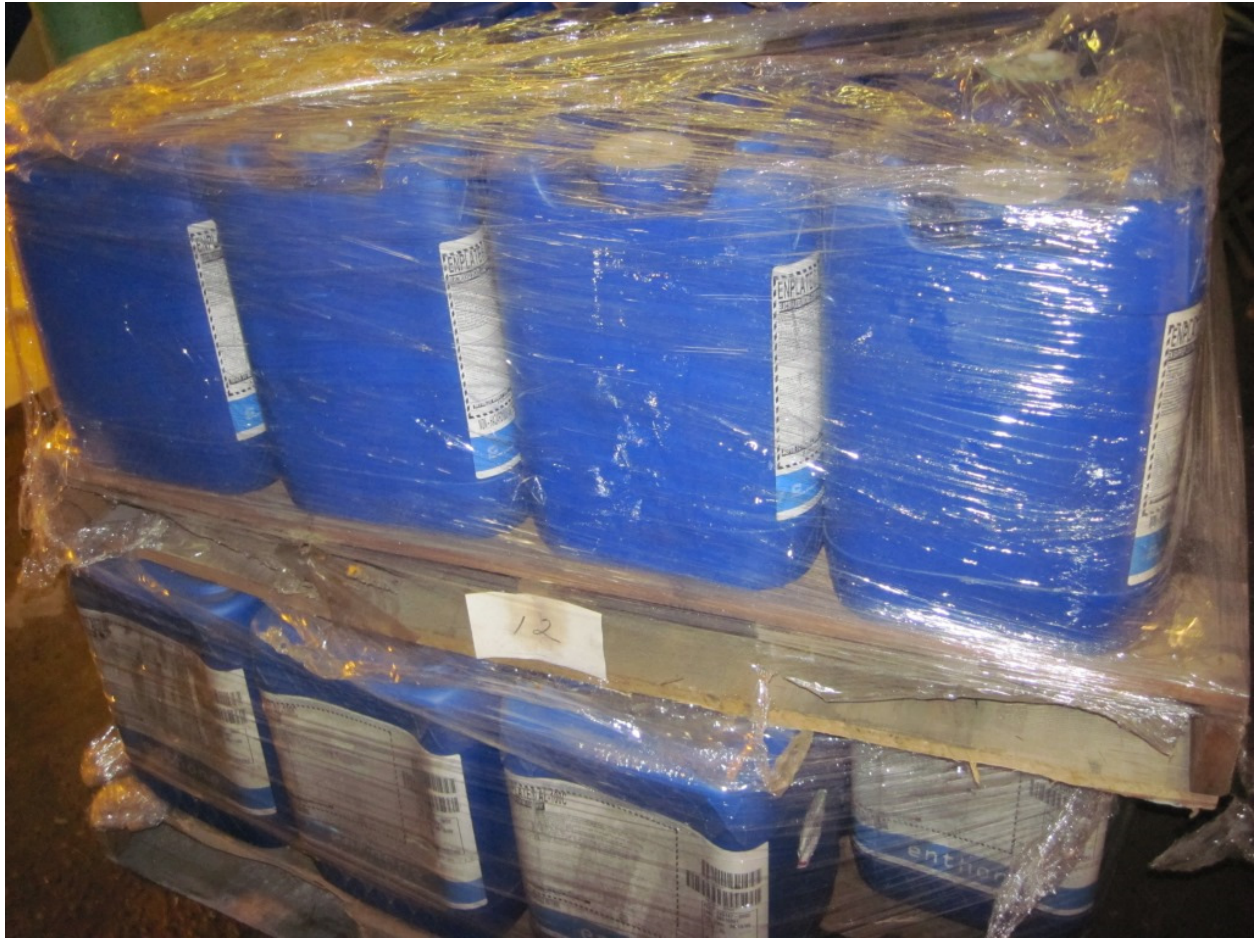
Photo 21: Overview of stacked and shrink-wrapped containers located close to the former Electropolishing Department.

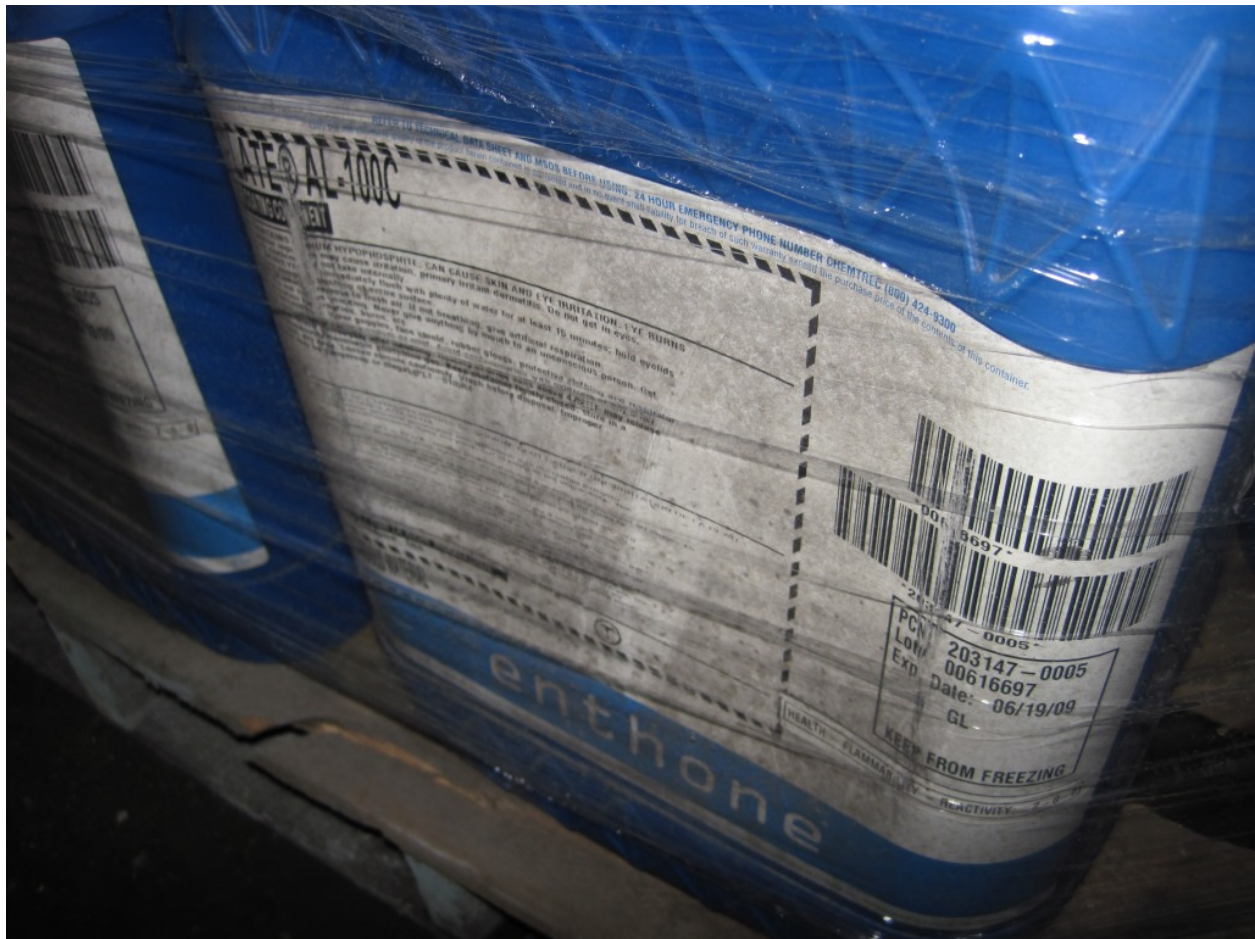
Photo 22: Close-up of one of the labels on a containers, as seen in Photo #21 above. The expiration date is 6/19/09.

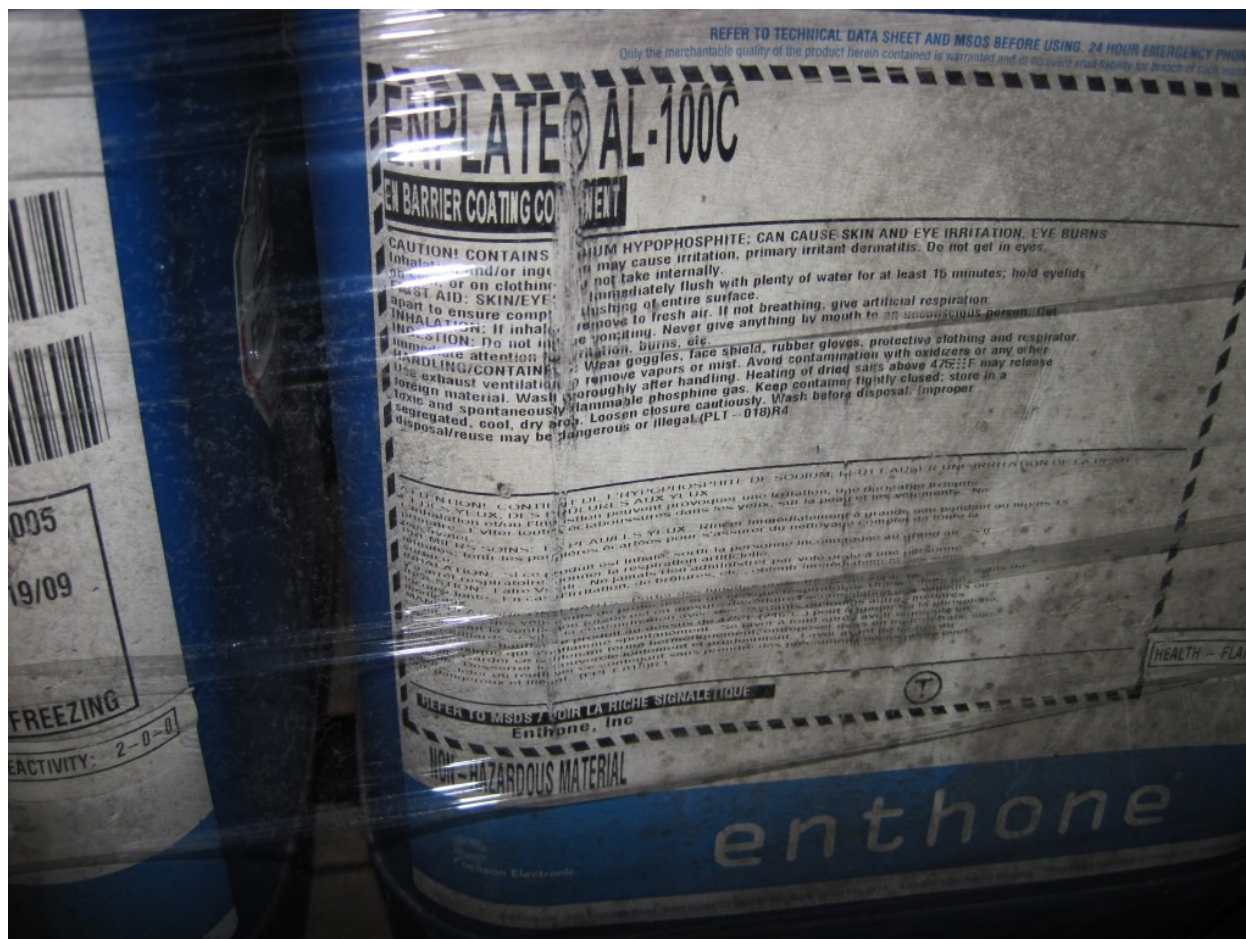
Photo 23: Close-up of a label on a container, as seen in Photo #21 above. The container is labeled with the words non-hazardous material.

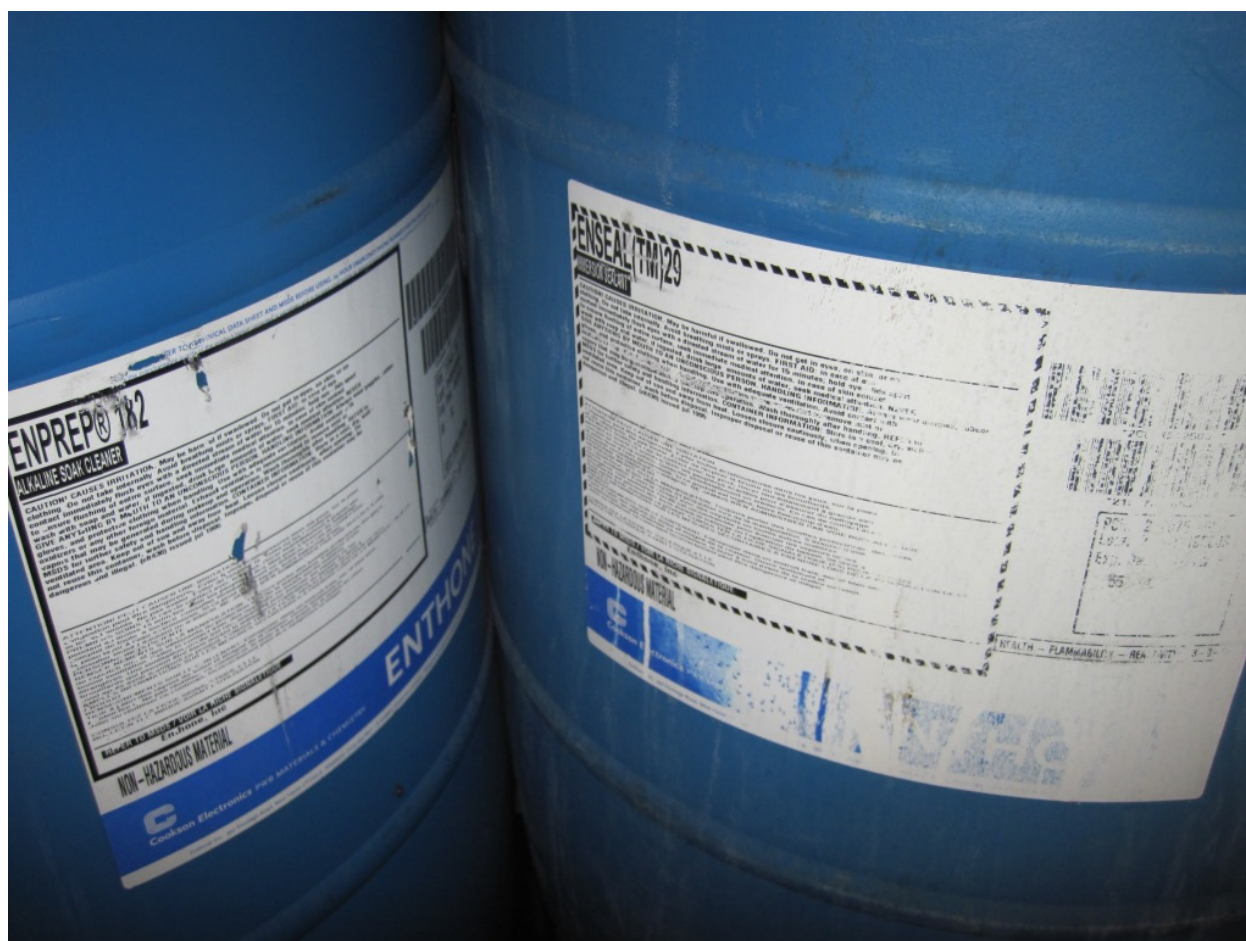
Photo 24: Close-up of labels on containers of cleaning solution located close to the former Electropolishing Department.

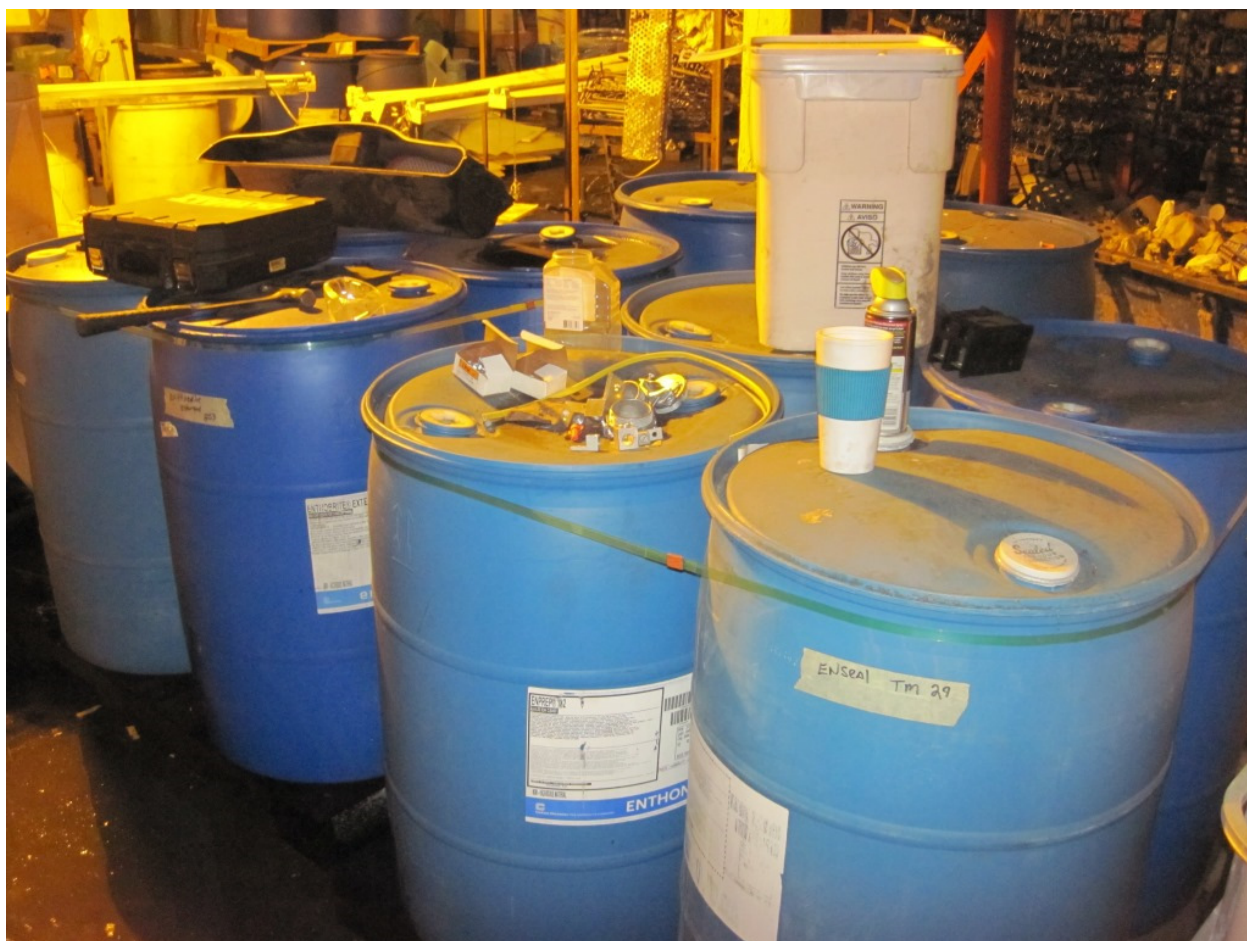
Photo 25: Overview of containers located close to the former Electropolishing Department.

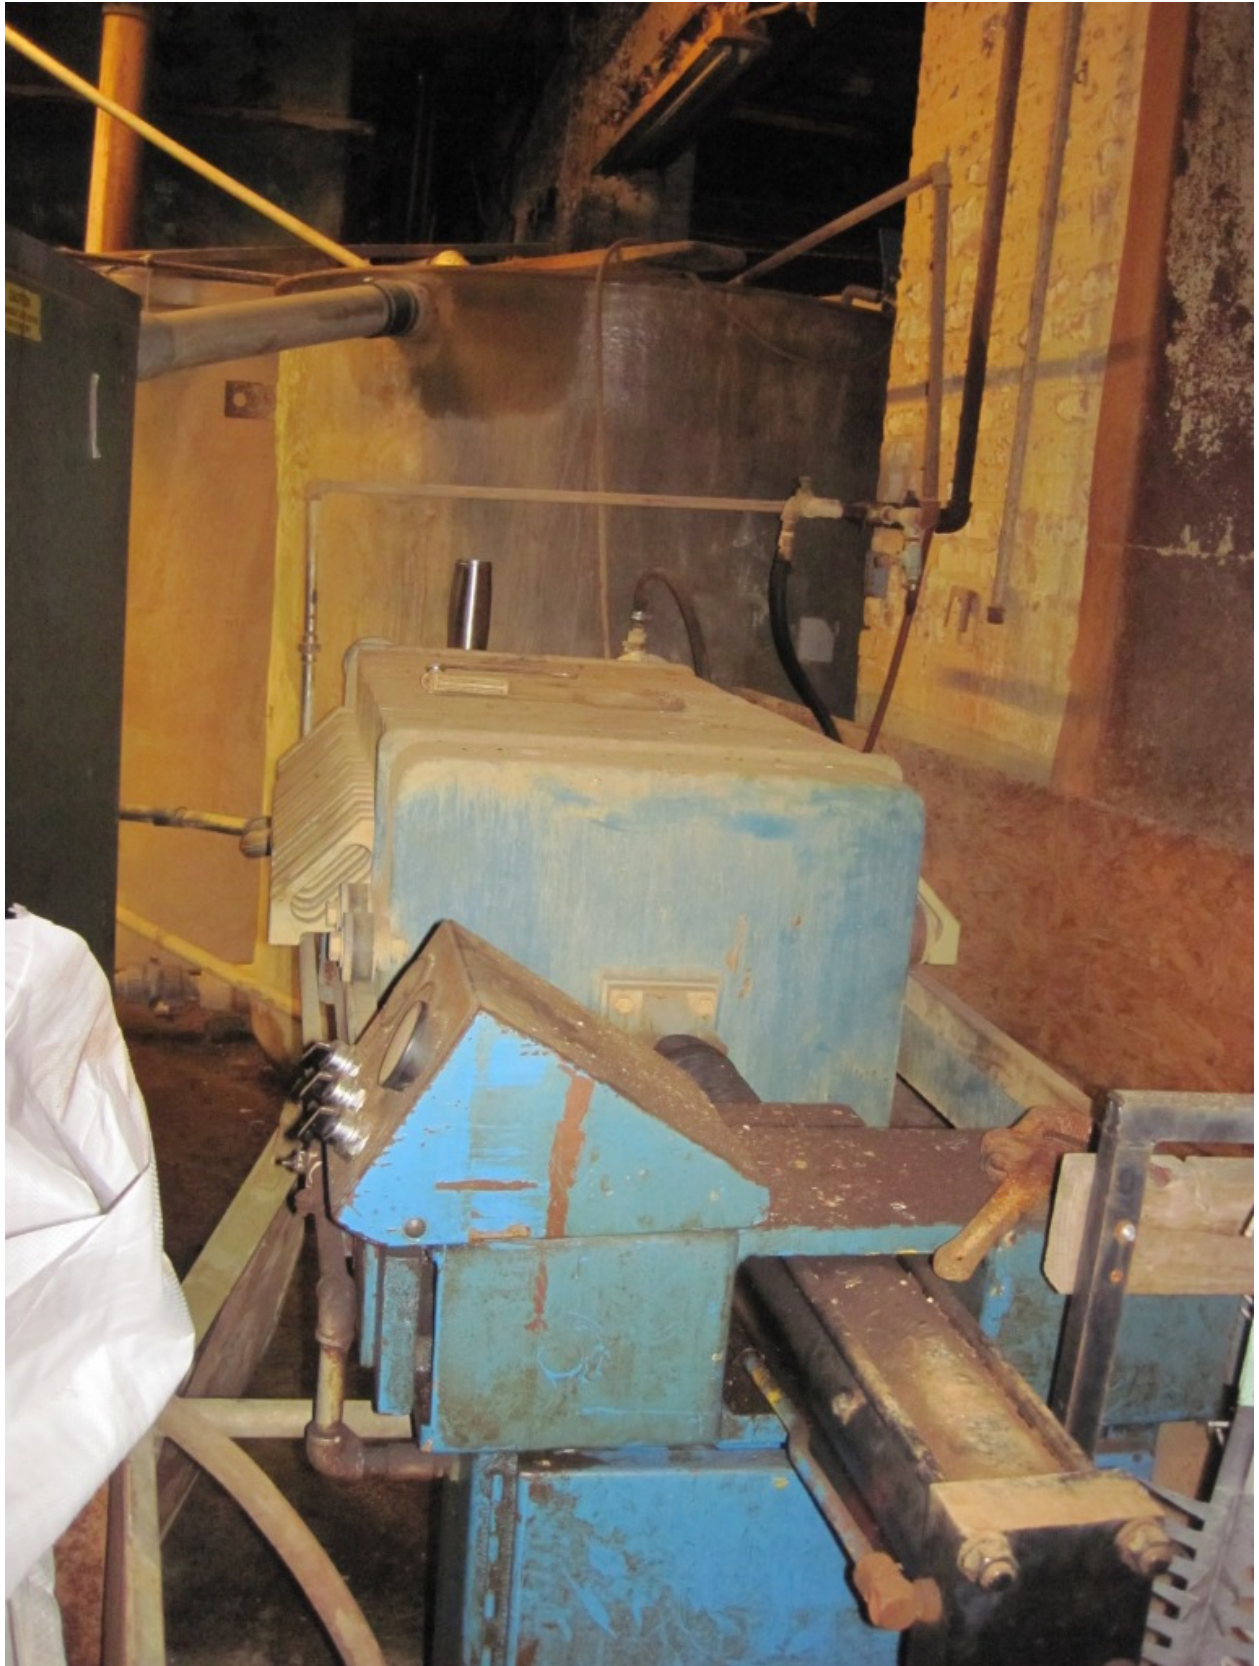
Photo 26: Overview of the WWTU sludge tank and the filter press.

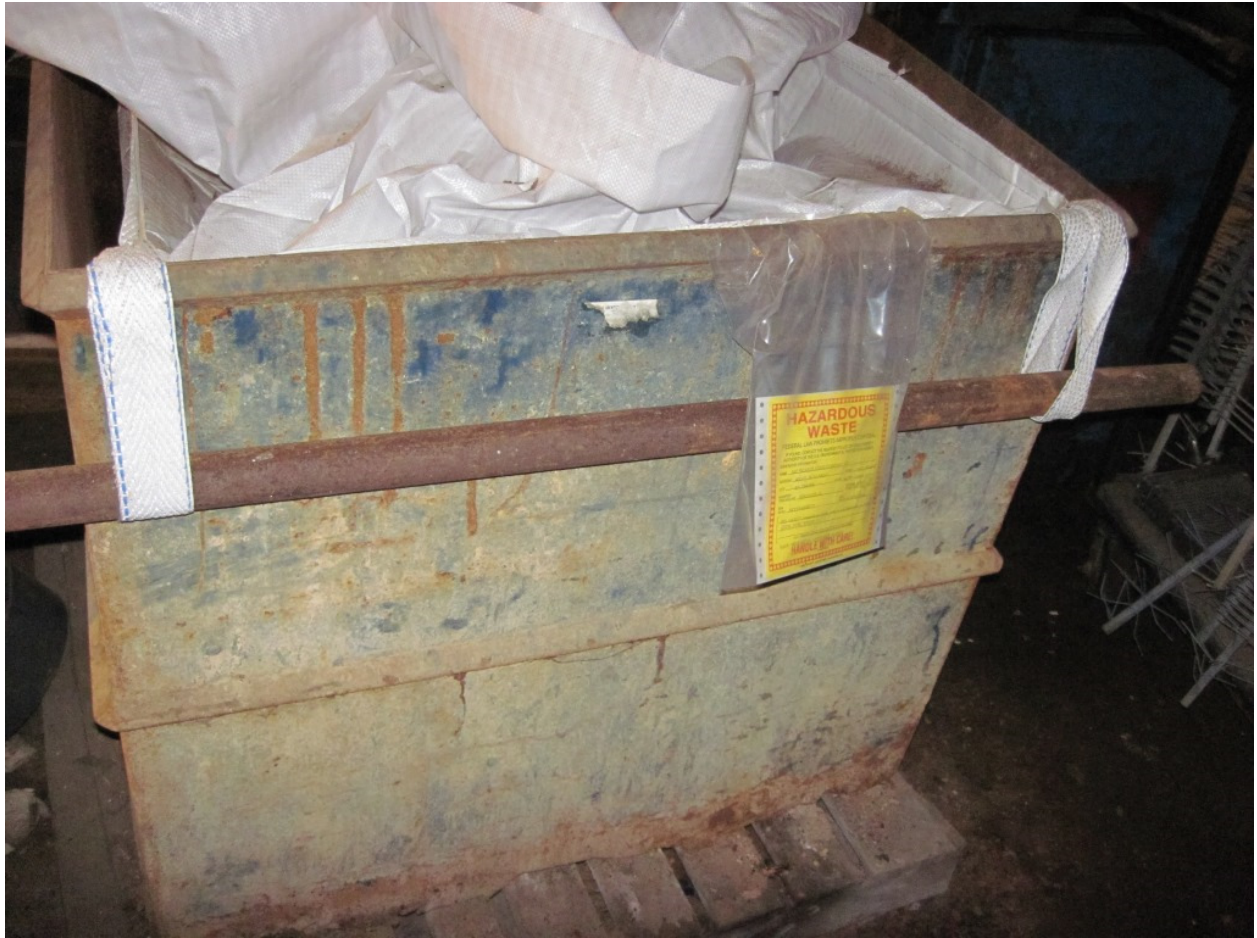
Photo 27: Overview of a container of WWTU sludge accumulated in a super sack.

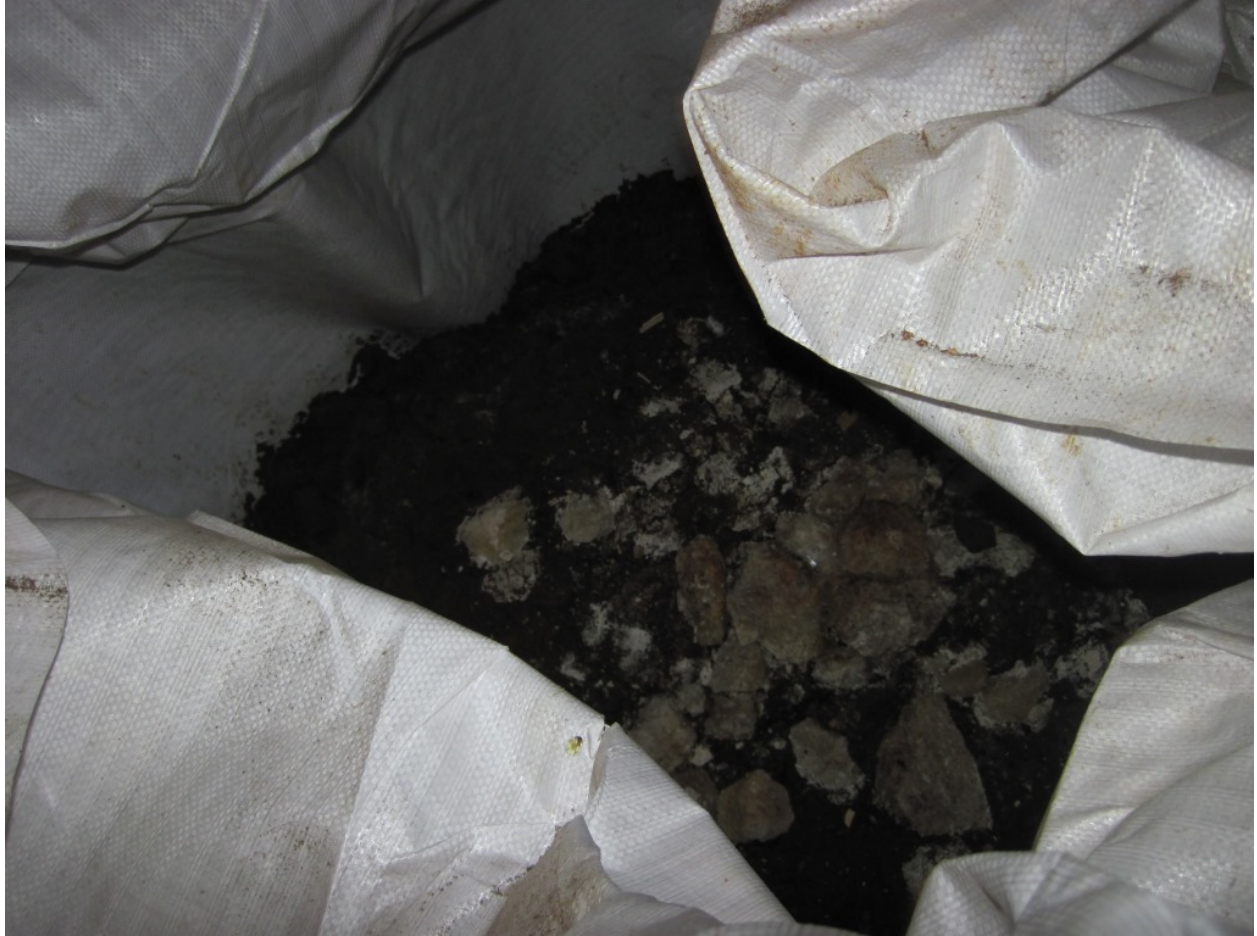
Photo 29: Close-up of the contents of the container, as seen in Photo #27 above. The container was partially filled with F006 waste, and it was open at the time of the inspection.

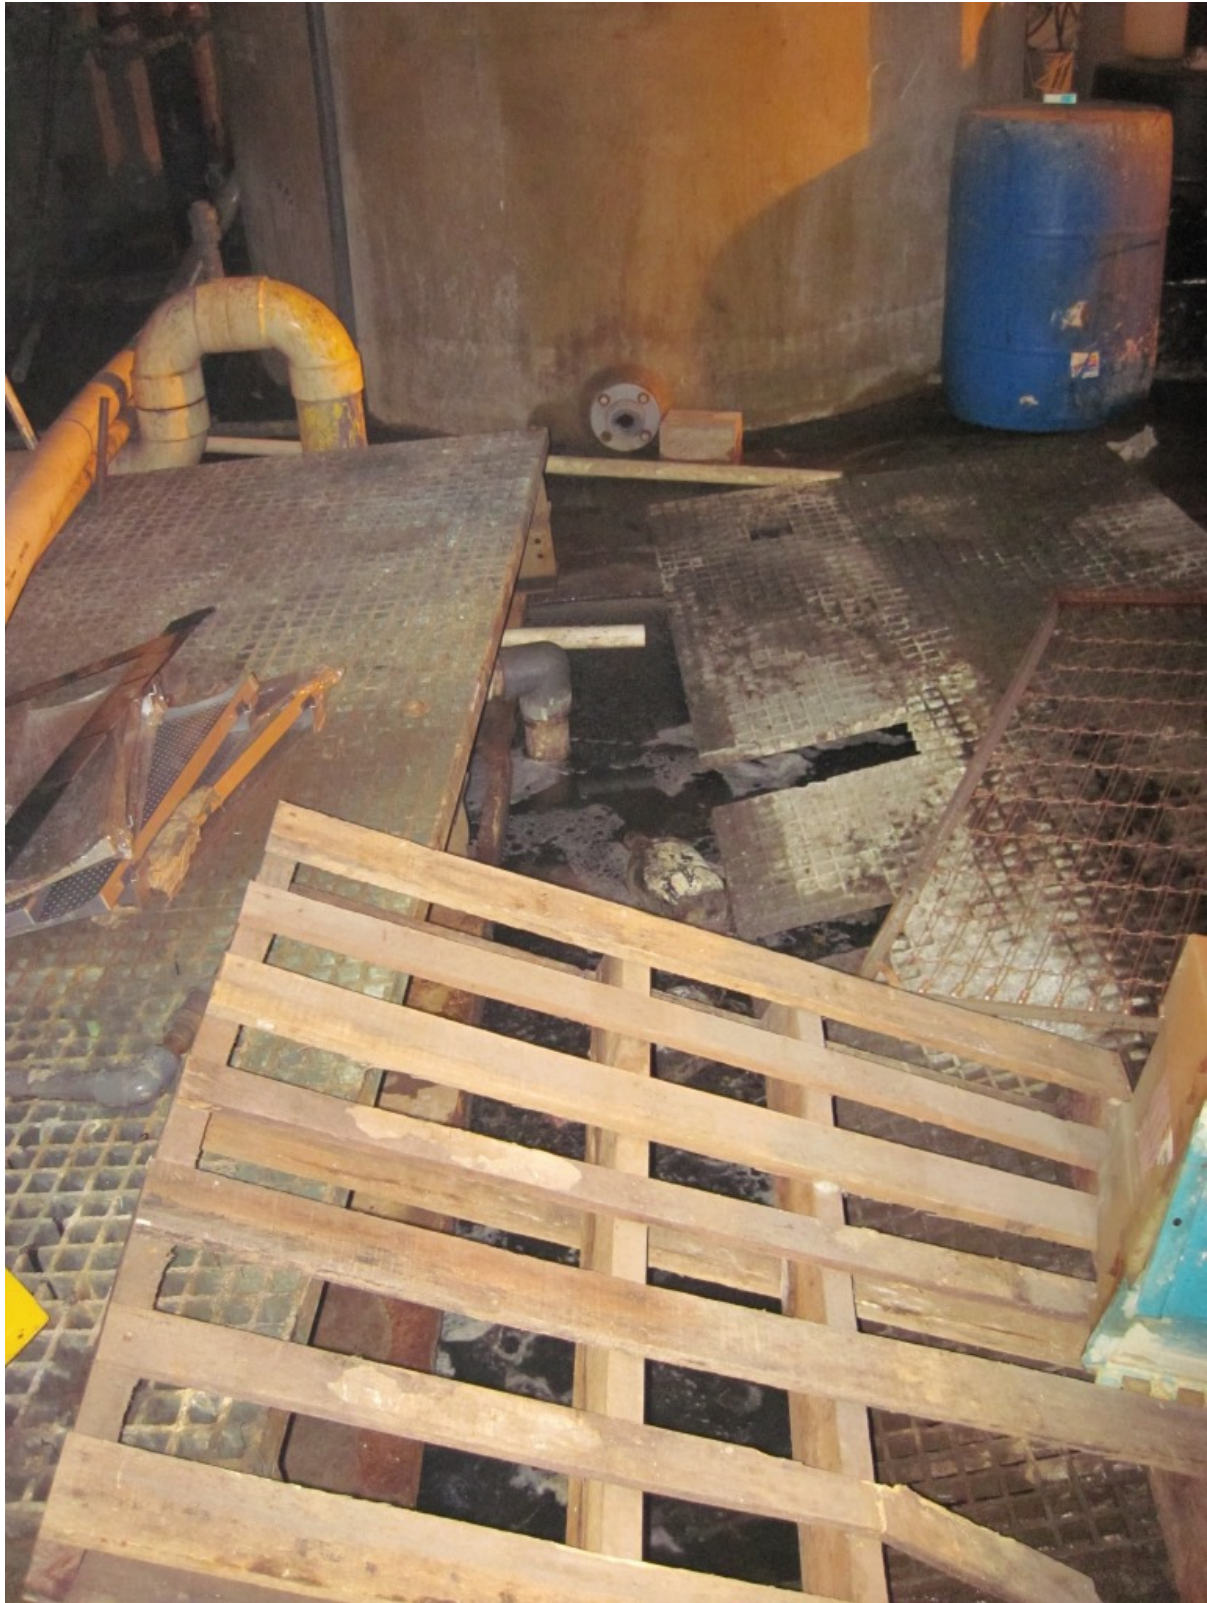
Photo 30: Overview of the WWTU pit, which was filled with liquid.

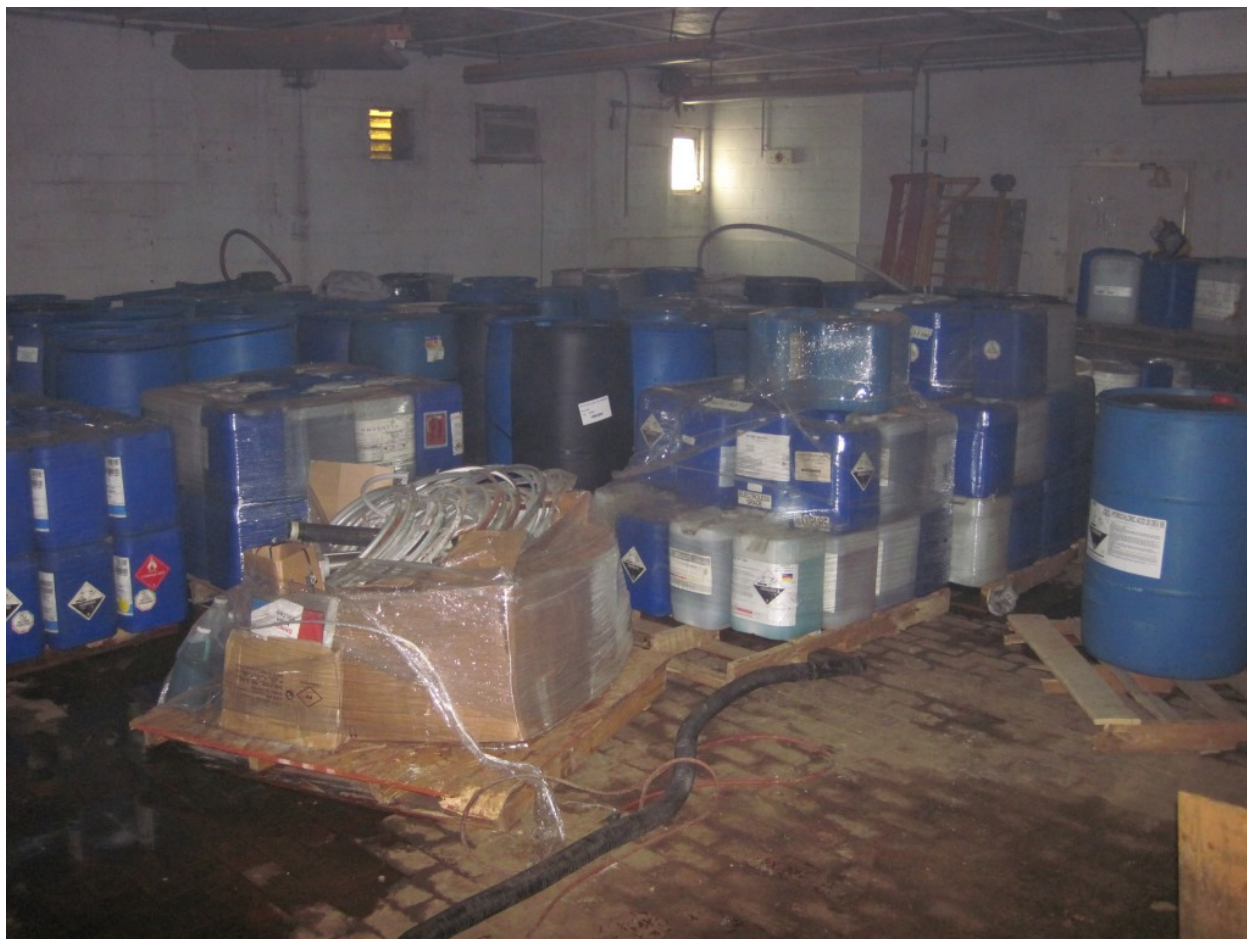
Photo 31: Overview of containers in the former chrome department.

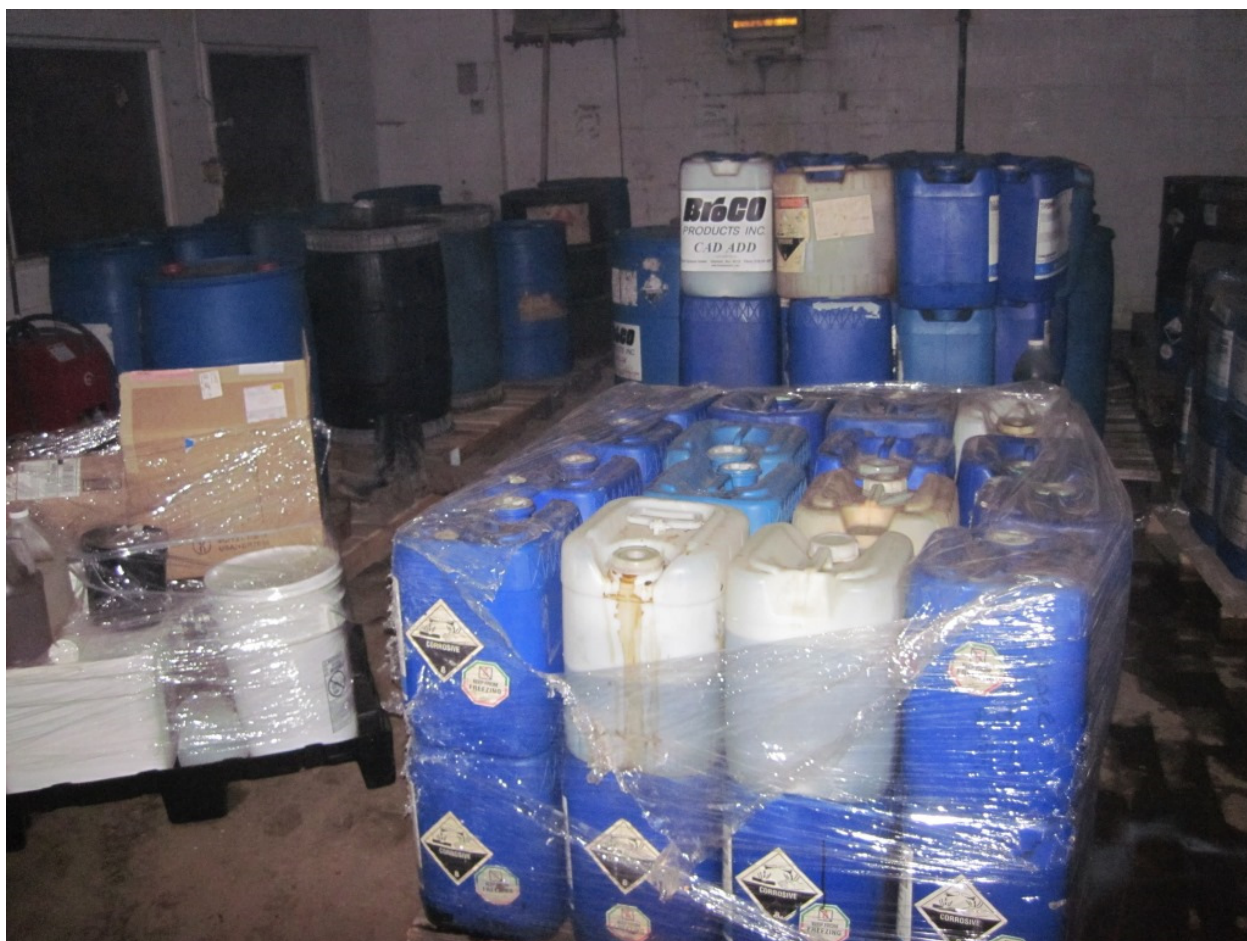
Photo 32: Overview of containers located in the former chrome department.

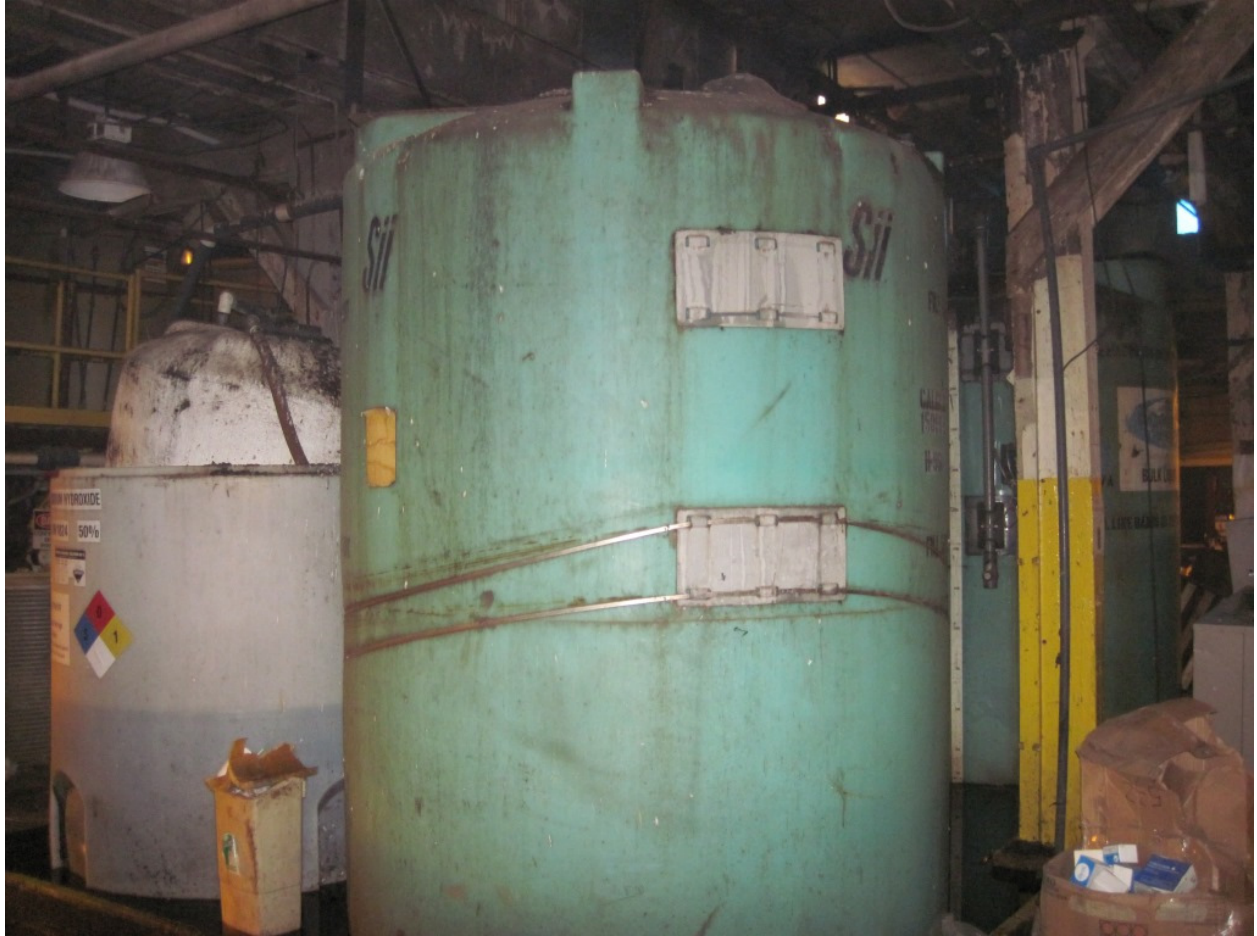
Photo 33: Overview of the WWTU process tanks.

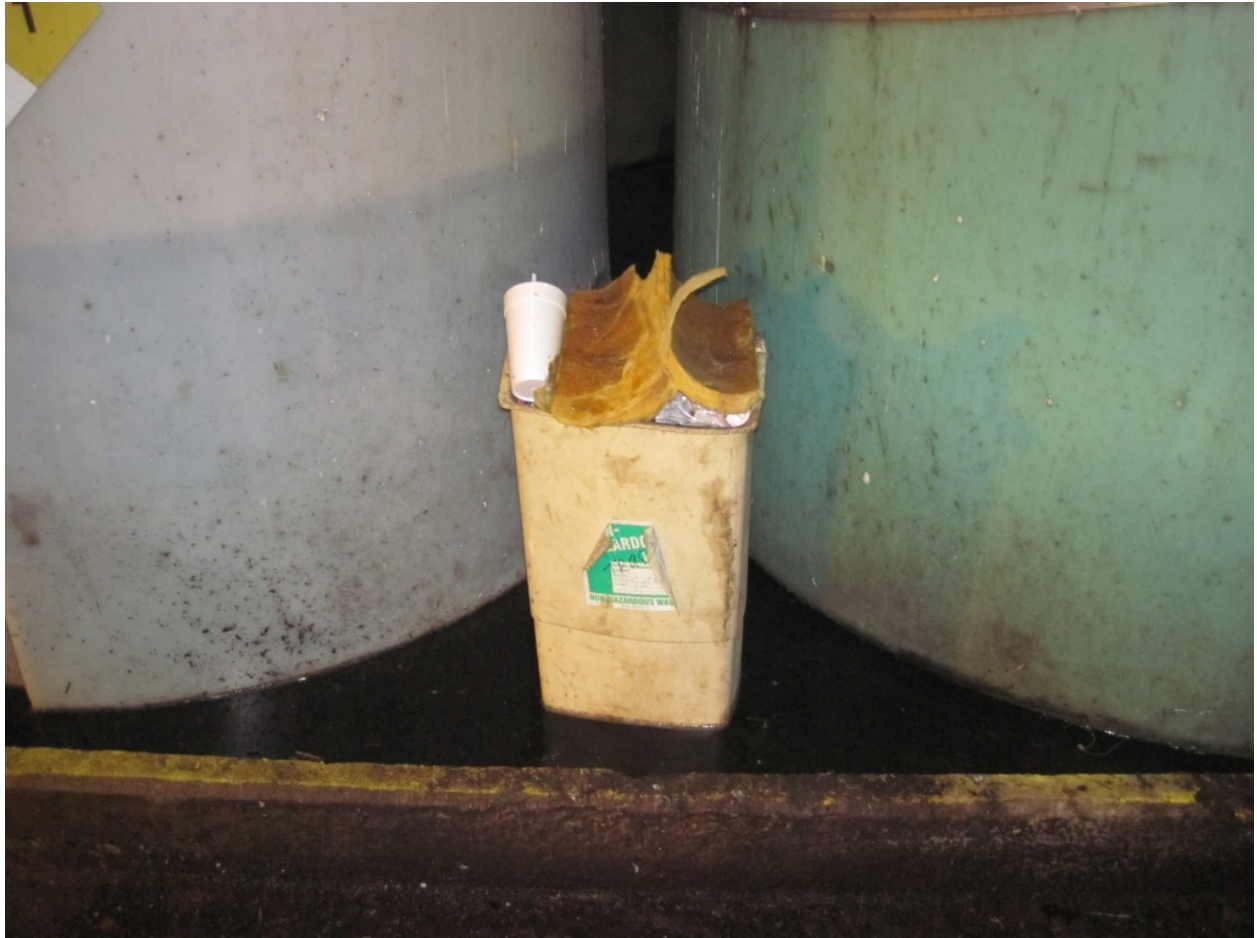
Photo 34: Overview of liquid in the secondary containment of the WWTU process tanks.

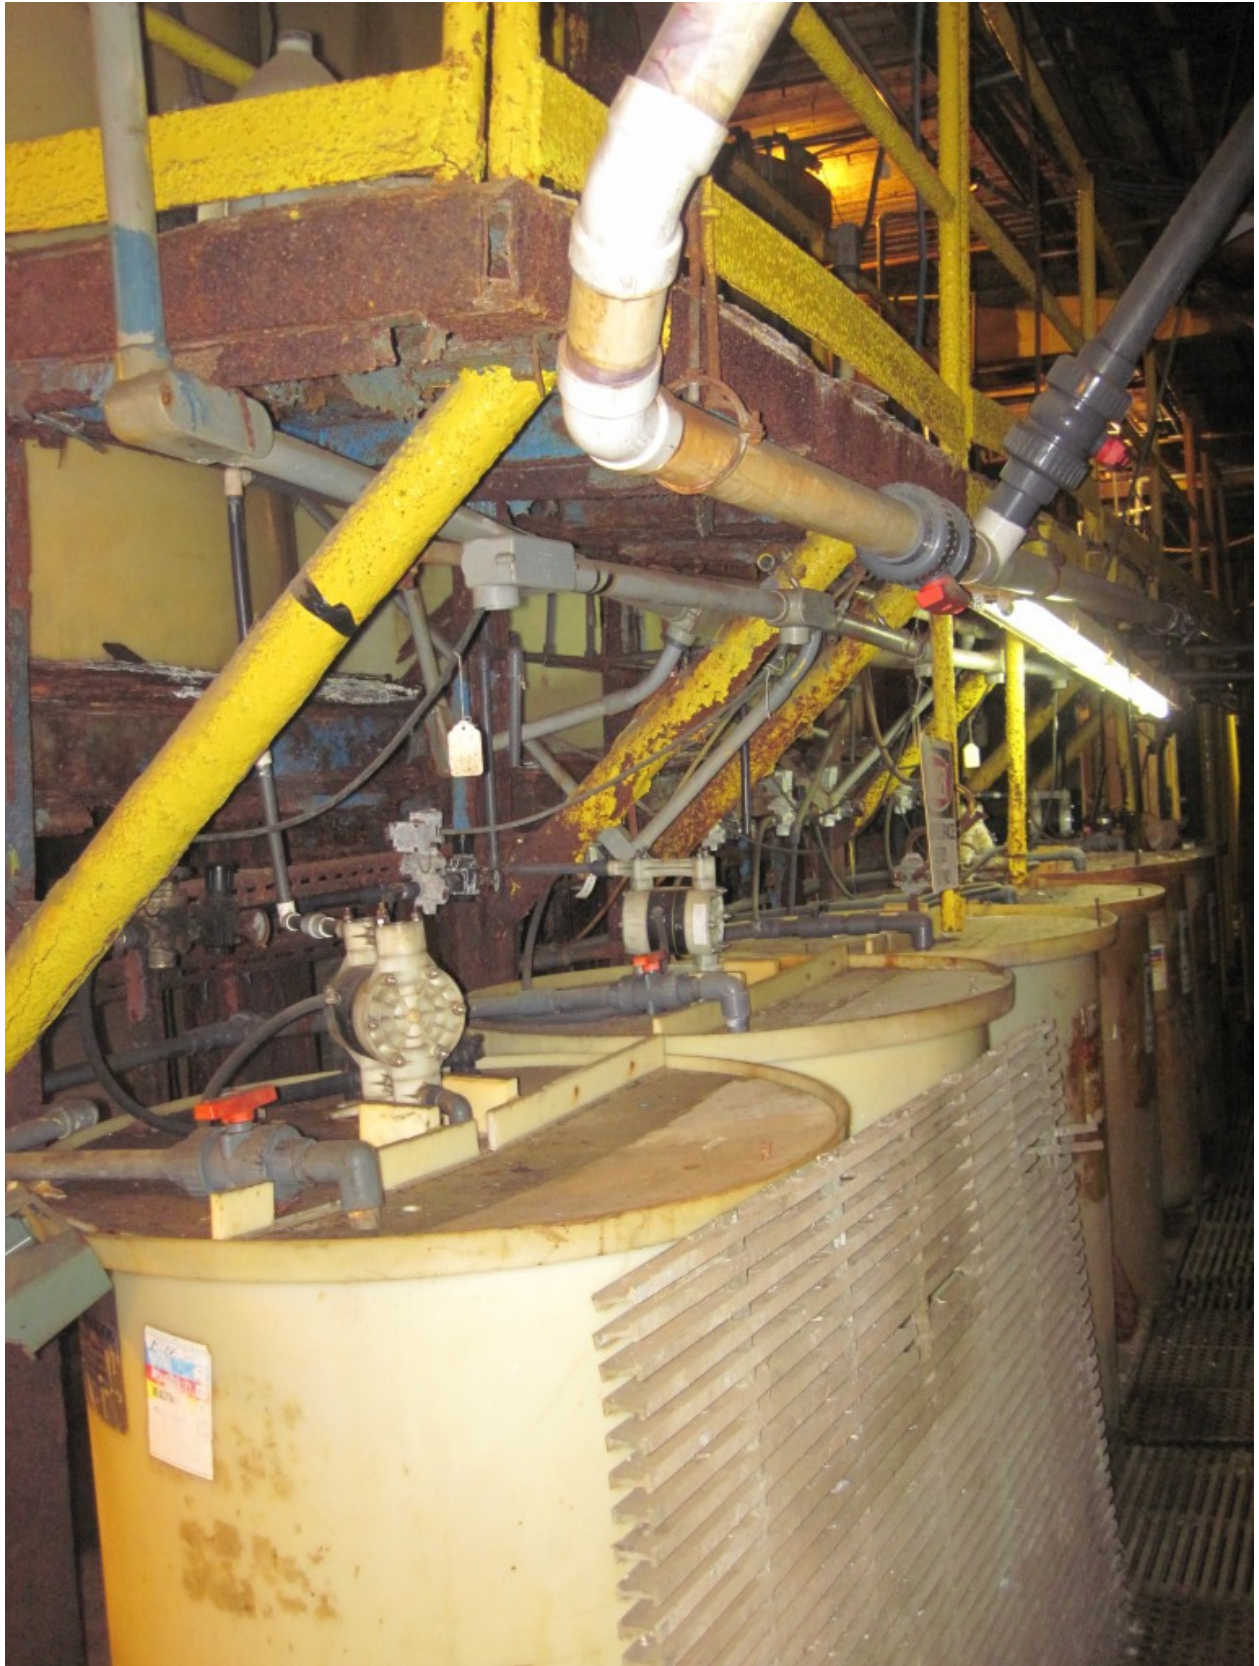
Photo 35: Overview of empty WWTU process tanks.
